AN EXTENSIVE STRUCTURAL MAINTENANCE PROBLEM CAUSED BY CORROSION ON AN AIRCRAFT

ABSTRACT

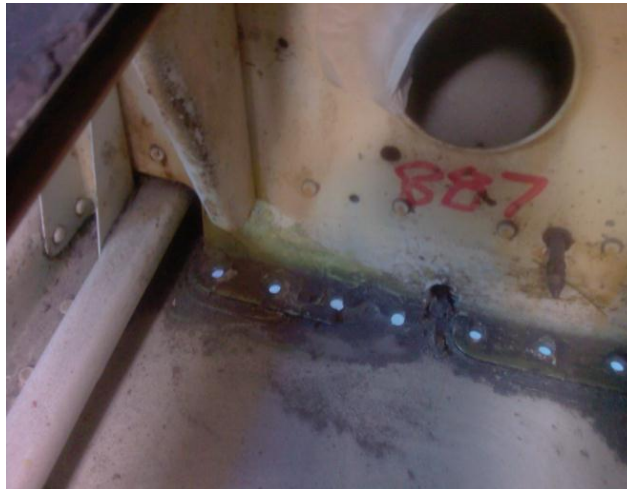
The Boeing 737-300 was taken into My Technic Aircraft MRO Services' Hangar to carry out its C check. After visual and liquid leakage inspection, extensive corrosion damage was seen in the aft cargo compartment. Previously, the same area of the aircraft had the same corrosion problem and so it had structural repair. However, for various reasons such as poor protection, inspection and leakage from the lavatory system etc, the same area became corroded again. The problem was more extensive than the previous case since it spread out to other important structural parts. A view of corrosion is given in Figure 2.

Figure 2: A View of the Corrosion in the Aft Cargo Compartment

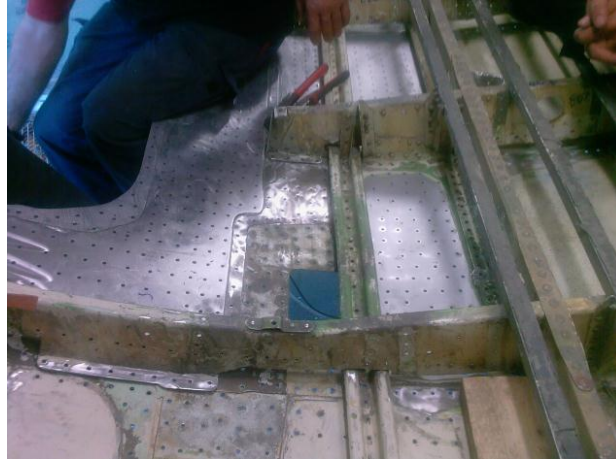
Firstly, traditional attempts to remove the corrosion in the aft cargo compartment were tried, but through a cleaning process, it appeared that the corrosion could not be removed. Therefore, the Structural Repair Manual (SRM) was examined to decide which method to use to get rid of this kind of corrosion. Eventually, it was clear that the SRM did not provide sufficient information about this extensive problem. A picture after the cleaning process is given in Figure 3.

Figure 3: Aft Cargo Entrance Door - Corrosion Cleaning

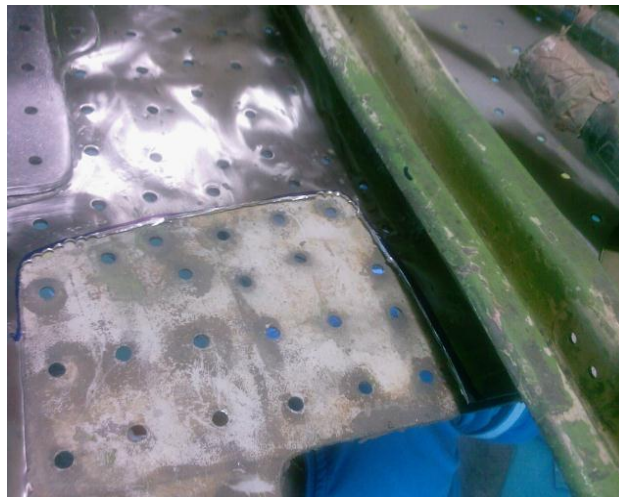
Figure 4: Removing Some Parts by Cutting from the A/C

As a result of correspondence between My Technic Aircraft MRO Services and Boeing Aircraft Company, it was decided to cut and remove heavily corroded parts from the A/C. A view of a cut in the aft cargo is given in Figure 4.

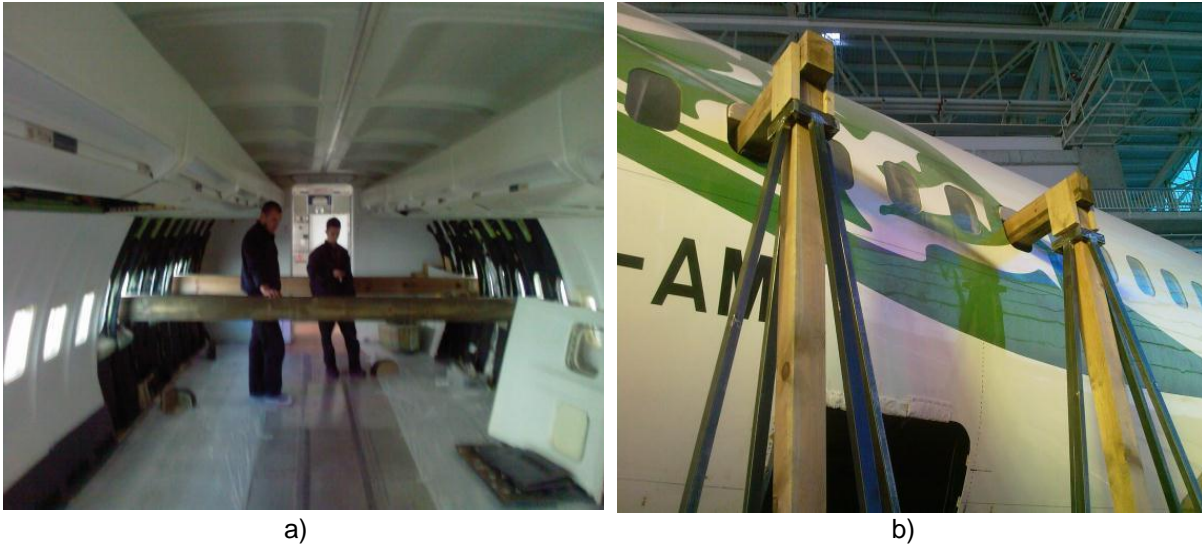
Figure 5: Preparation of the A/C for Structural Repair, a) The Poles put through Windows b) The Poles' Tips and Their Attachment with Vertical Poles.

After removing passenger seats and jacking the A/C, two poles were put through the windows of the A/C. On each side of these poles, four other poles were attached vertically as seen in Figure 5.

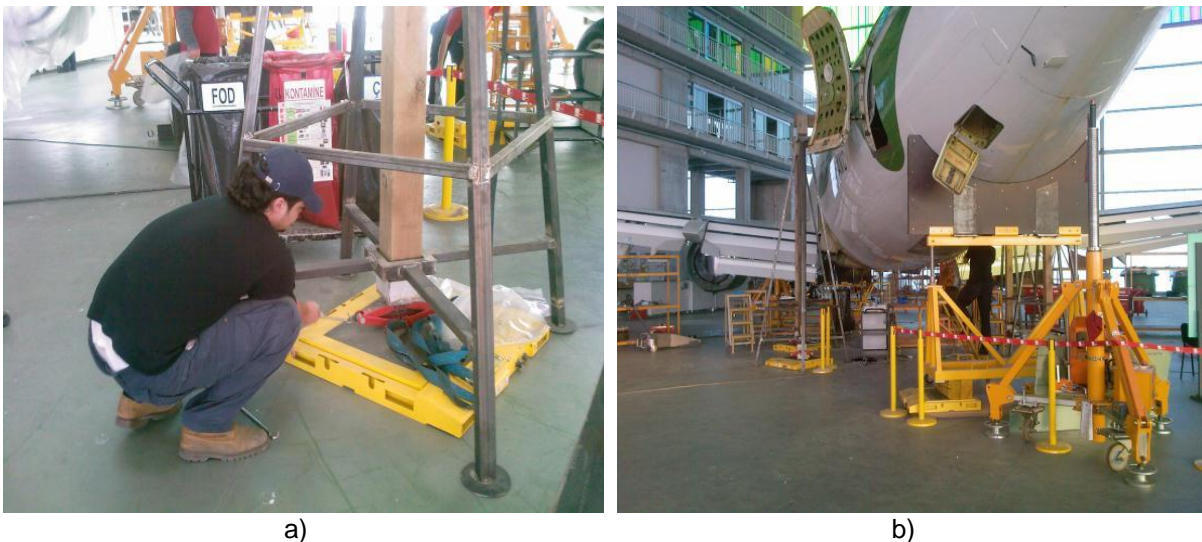
Figure 6: Preparation of the A/C for Structural Repair, a) A Structural Maintenance Technician is putting a Scale under one of the Poles. b) General View of the Preparation.

A scale was used under each vertically attached pole to measure the changes of weight balance. The scales were checked daily to prevent the A/C from shifting. In addition, the aircraft was supported from its tail cone and under the fuselage. The process is seen in Figure 6.

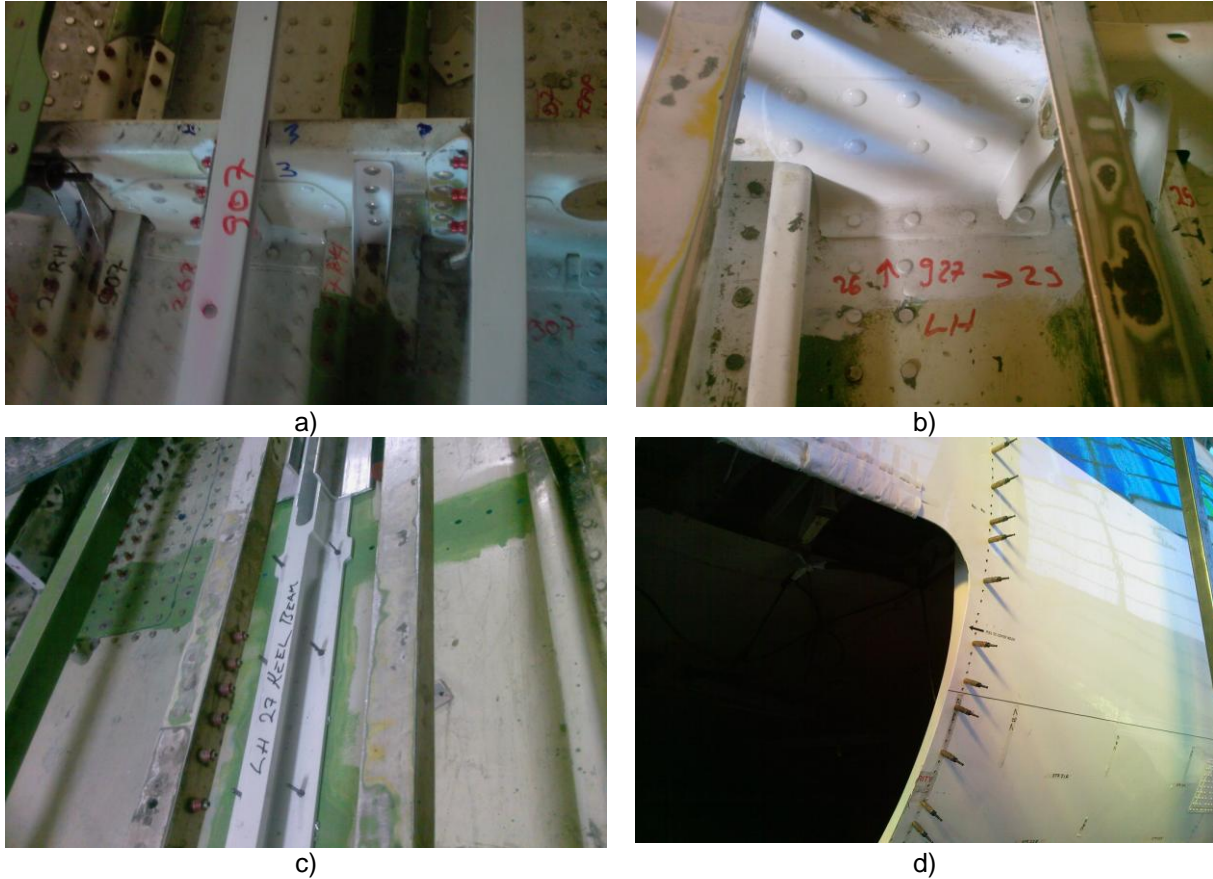
Figure 7: Some Changed Parts on the A/C. a) 907 Body Station Numbered Stringer Change b) 927 Body Station Numbered Frame Repair c) L/H 27 Numbered Keelbeam Change d) 767 Body Station Numbered Door Frame Change

Except for the parts removed by cutting, in the aft cargo compartment, 747, 767, 787, 827, 847 and 887 body station numbered frames were changed. Also, some stringers and struts were changed. Some of them are seen in Figure 7.

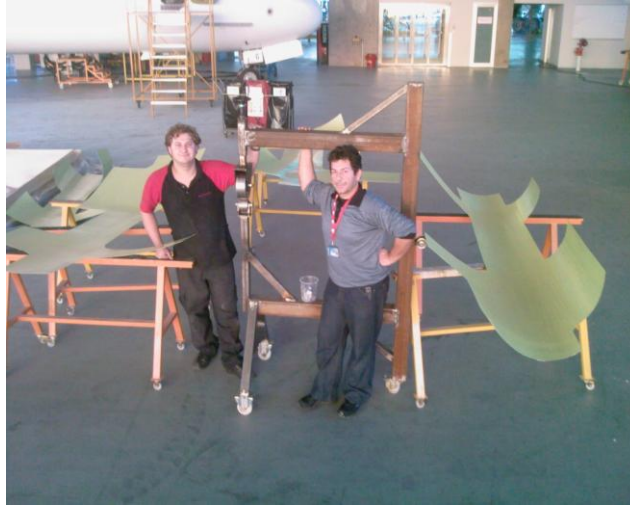
Figure 8: English Wheel Tool and Structural Maintenance Technicians

After removing some structural parts, frames, stringers and struts, necessary measurements were done in length and width to determine the dimensions of patches. The thickness of the aluminum sheets was calculated thicker than the original sheets in that area. The aircraft manufacturer, Boeing Company, sent the technical drawing of the patches with the suitable sheet thicknesses. In the drawing, a five-stage patch with dimensions of 2.7 meters in length and 1.6 meters in width was given and the thicknesses of the sheets were, from the inside out, 0,032, 0,050, 0,063, 0,071, and 0,125 inches, respectively. The patches were prepared one by one by means of English Wheel Tool according to the technical drawing. Two or four Aircraft Structural Maintenance Technicians took part in preparing each patch. Preparing a patch took three days. In other words, a huge effort was spent. Figure 8 shows the English Wheel Tool and Structural Maintenance Technicians.

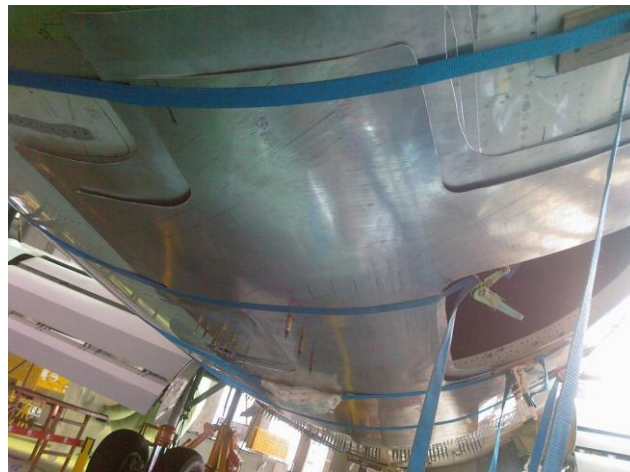
Figure 9: Fastening the Patches to the Fuselage of the A/C

Since the patches are rather large, they were fastened to the fuselage of the A/C by means of belts. After that, necessary drilling processes were carried out, taking into consideration the old holes from the previous structural maintenance. How the patches were fastened to the fuselage is seen in Figure 9.

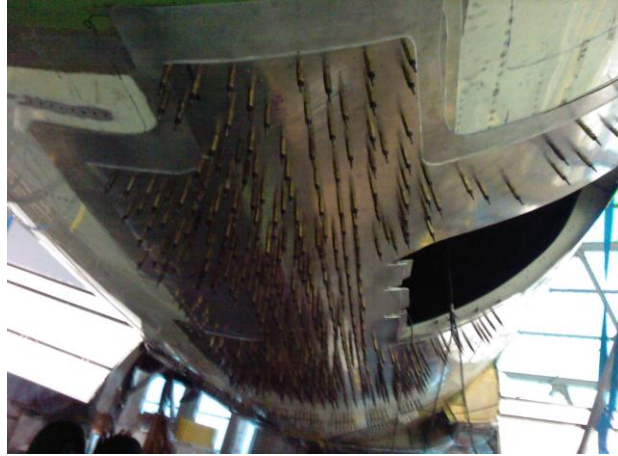
Figure 10: Drilling the Patches and Fastening to the Fuselage Temporarily

Except for making sure that the patches fastened properly to the fuselage, the drilling process should be conducted meticulously. Otherwise, the inner patches may be damaged, which causes loss of money and time. Figure 10 illustrates the drilling and temporary fastening process.

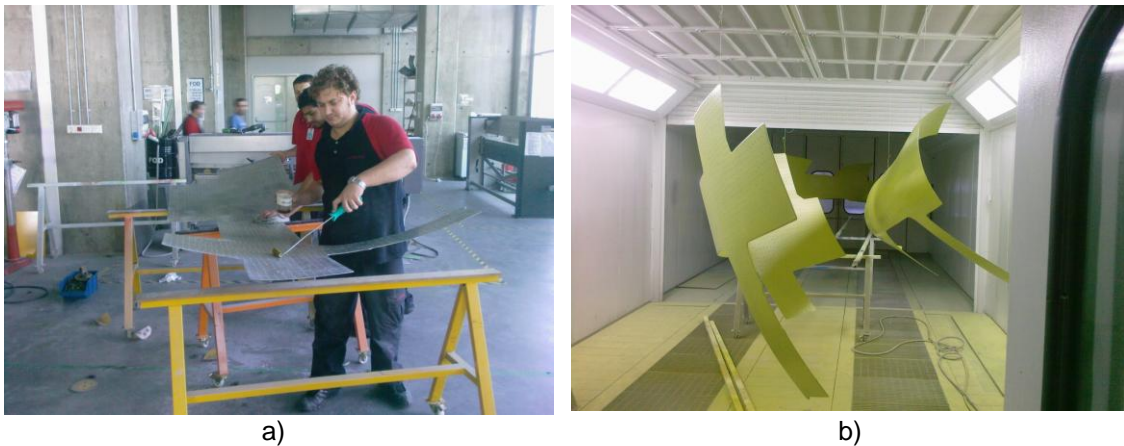
Figure 11: Preparation of Patches a) While Applying Protective Solution b) Patches in the Paint Drying Oven

After the drilling process of all patches, the patches were trimmed and then undercoated in a paint workshop. Figure 11 includes photos from this process.

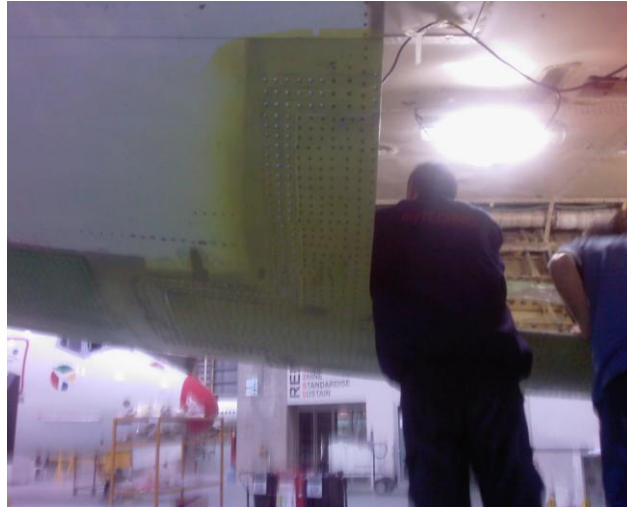
Figure 12: Final Status of the Structural Maintenance

In structural maintenance, aluminum alloy patches recommended by the manufacturer were used. For this maintenance, 2024T3 aluminum alloy based sheet metals were utilized. Final status of repair is given in Figure 12.

After completing the structural repair, system parts, which caused the leakage, were changed and checked. A Cabin Pressurization Test was applied and no air loss was detected. Afterward, the patches and other poorly painted parts were painted. At the end of the maintenance, it was specified that the maintenance did not cause any large change in A/C center of gravity, with approval of the Boeing Company. The A/C was released to service after conducting all other maintenance.
