14-16 September 2011 - METU, Ankara TURKEY

**ANALYSIS, DESIGN AND MANUFACTURING A WINDOW FRAME WITH RTM METHOD AND ASSEMBLING CURED WINDOW FRAME TO UNCURED PANEL WITH CO-BONDING METHOD**

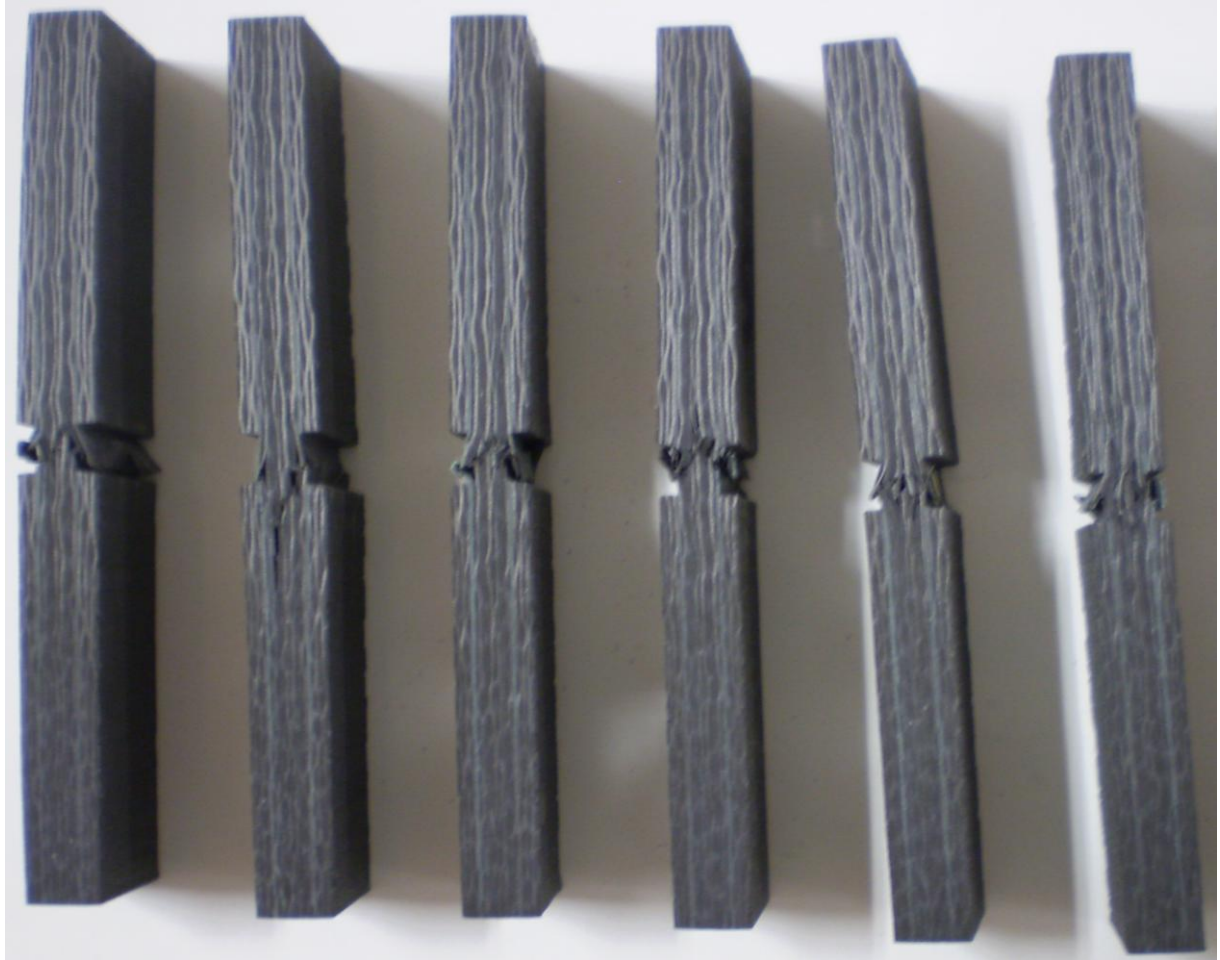
Fig. 10: Compression test specimens

The plain strength calculation method is used to predict the failure strength of plain composite laminates of window frame. Fibre failure is calculated using Yamada-Sun criterion and matrix failure is calculated using Puck criterion. Plain strength analyses were verified by test results (Fig 10 and Fig 11).

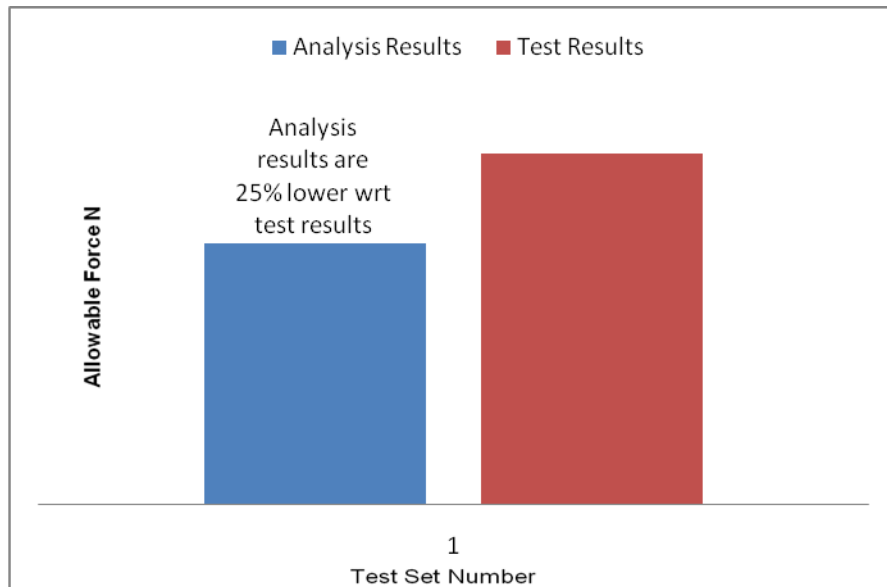
Graph 1: Shear properties comparison, analysis vs. test

Comparative results of tests and analysis are shown in Graph 1, Graph 2 and Graph 3.

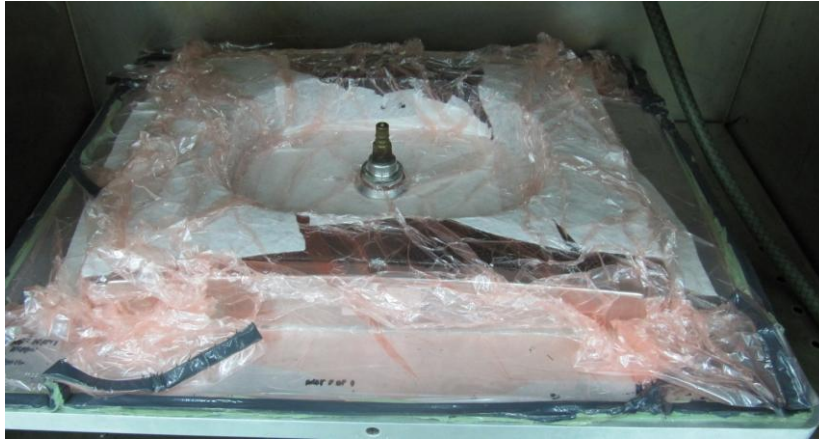
Fig. 25: Compaction and heating process of preform

All tool surfaces are cleaned out of dust, residual resin and contaminants. Release agent is applied on molding surfaces. Dry fabrics are laid up on mold surface and each and every layer is subjected to compaction (Fig 25). After compaction fabrics are heated up to definite temperature in order to activate binder in fabrics while maintaining vacuum with the help of a vacuum bag. Binder helps to prevent disintegration of the preform by sticking plies to each other (Fig 24).

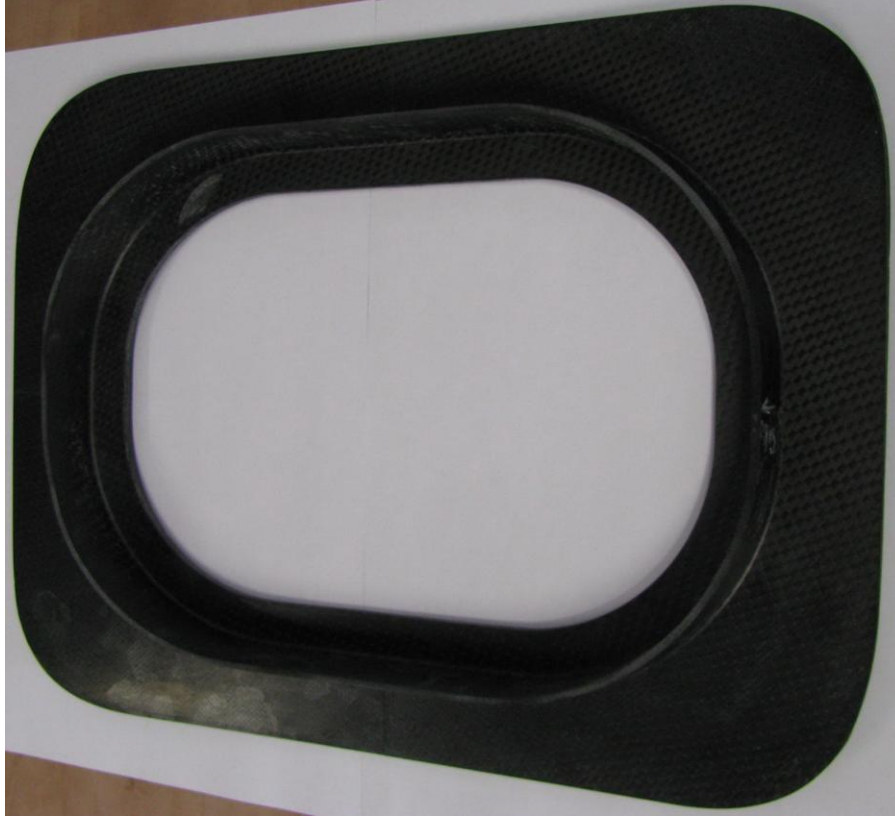
Fig. 28: RTM window frame

Cured part is removed from tool after cure cycle was completed. Cured parts are subjected to non-destructive ultrasonic inspection. An RTM cured window frame is shown in Fig 28.
