AN EXPERIMENTAL INVESTIGATION ON BENDING BEHAVIOR OF REPAIRED POLYMER SANDWICH COMPOSITE PANELS

ABSTRACT

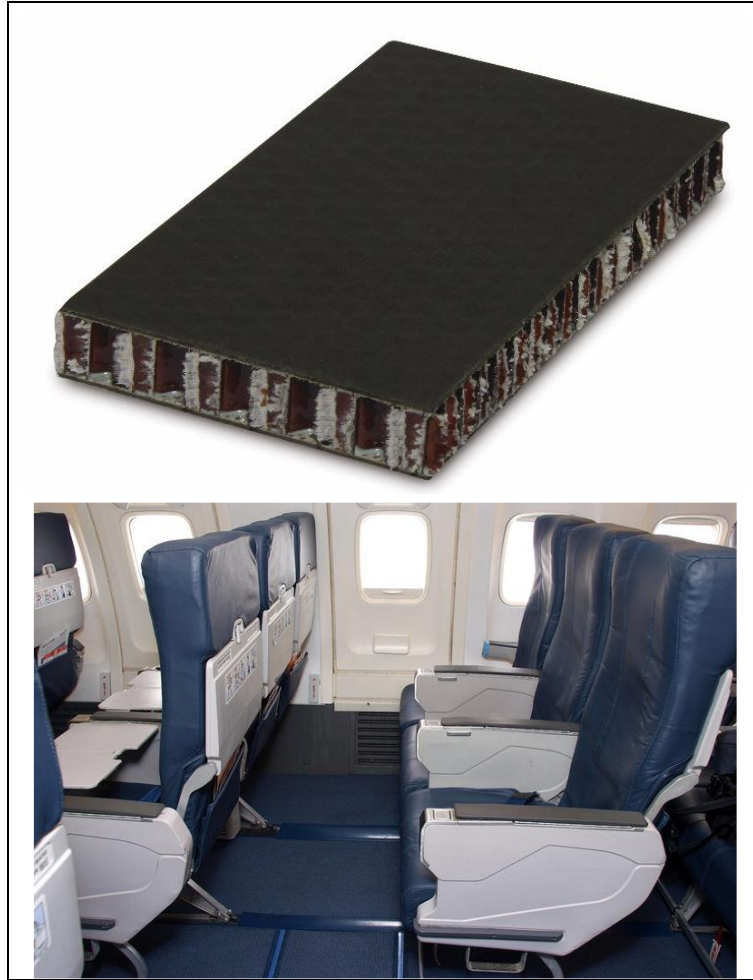
Figure 1: Gillfab® 4505 sandwich composite panel and the application of flooring panel [The Gill Corporation, 2021]

Gillfab® 4505, which has high strength and rigidity with light weight, is a hybrid composite sandwich panel reinforced with woven fiberglass and unidirectional carbon fiber bonded to a Gillcore® HD meta-aramid honeycomb core. Its applications are used for heavy duty use in passenger aisle and galley areas and flight compartments for Airbus A318/A319/A320/A321/A330/A340 aircrafts. Phenolic is used for facings resin system and epoxy is used for bonding adhesive [The Gill Corporation, 2021]. Figure 1 shows Gillfab® 4505 sandwich panel and the application in passenger aisle of an Airbus model. The dimensional properties of the panel are detailed in Table 1.
